CIED Diagnostics

Device Troubleshooting: CRT builds on ICD builds on Brady

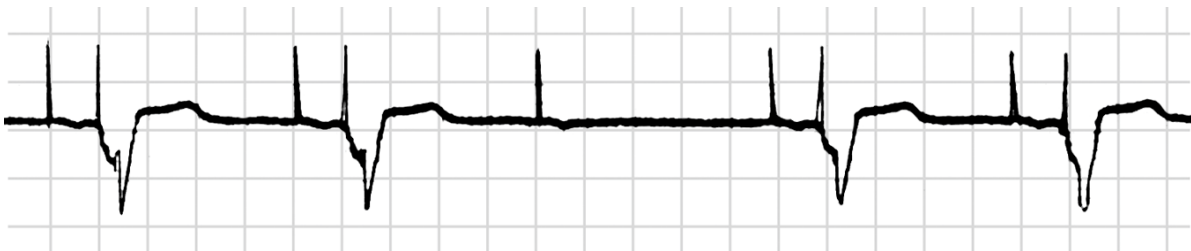
3.9 The ECG is obtained the morning after pacemaker implant. Which of the following is the most likely problem?

1. Crosstalk in absence of safety pacing
2. Ventricular lead dislodgment
3. Artifact
4. Ventricular lead fracture
5. Myopotential over-sensing

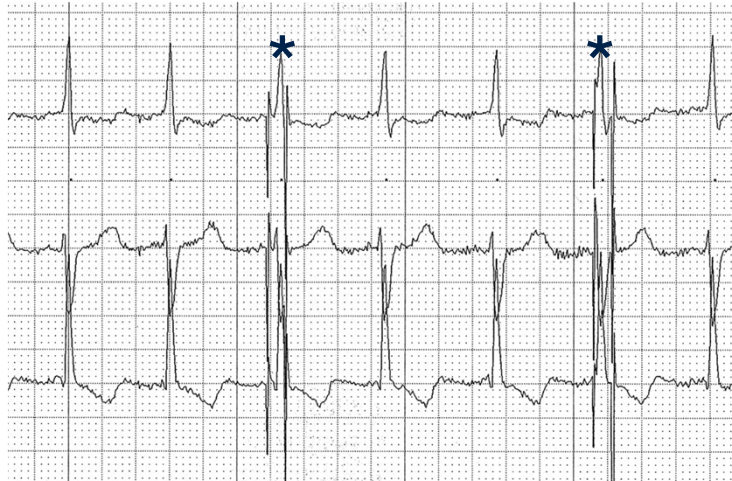
3.11 The programmed P-AVI is 240 ms. Labeled QRS complex (*) occurs in:

1. Crosstalk sensing window
2. Post-Atrial Ventricular blanking period
3. Alert window

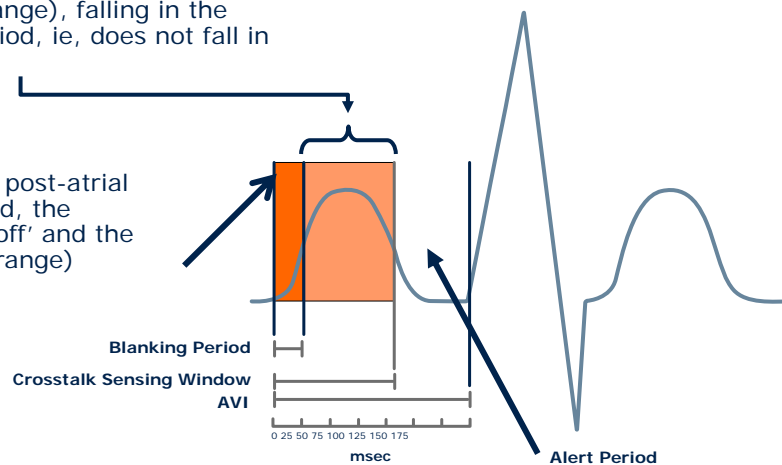
If the event occurs in the crosstalk sensing window is sensed, the V is paced after an abbreviated AVI (light orange), falling in the physiologic refractory period, ie, does not fall in the vulnerable period

If the event occurs in the post-atrial ventricular blanking period, the sensing circuit is turned 'off' and the event is not seen (dark orange)

If sensing occurs during the 'alert' period, ventricular output is inhibited.
